# Inspection Report

## River Valley Inspections LLC

7777 Elm st.  
Mountain Home  
Idaho

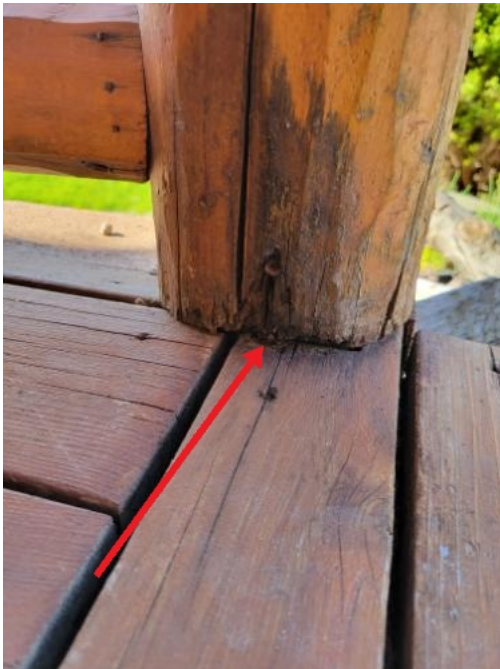
**2.1) Front Entrance Conditions**

The openings in the railings appear too wide. We recommend decreasing the opening length between the balusters to reduce the possibility of child injury. Client should consult with a deck contractor for information on current standards. Moisture damage was observed at the base of the 1st column.

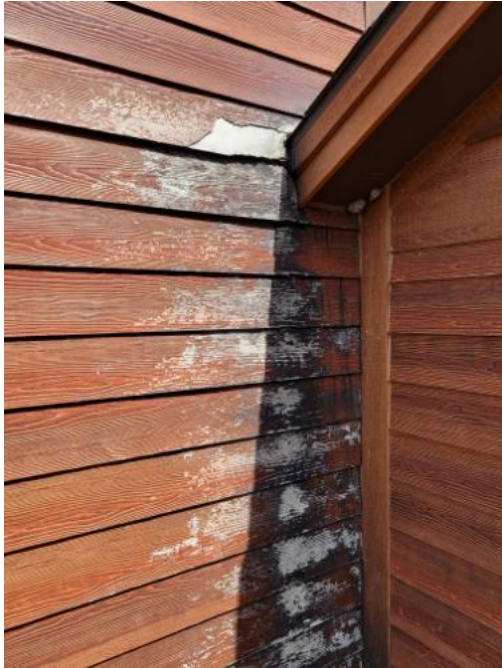
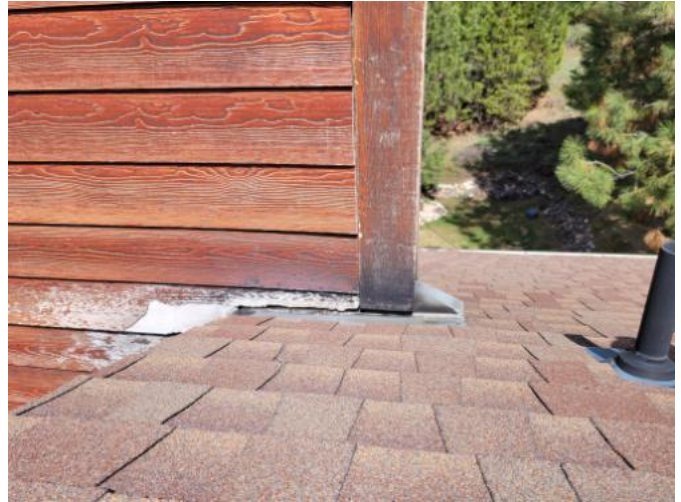
**2.3) Exterior Wall Conditions**

Common cracks were found in the exterior walls. Recommend sealing to reduce the possibility of water penetration. The paint / finish of the siding / walls was weathered. Recommend maintenance as needed by a qualified contractor. Moisture damage and possible evidence of water penetration were observed at . Due to conditions observed, hidden damage may exist in areas not visible or readily accessible.

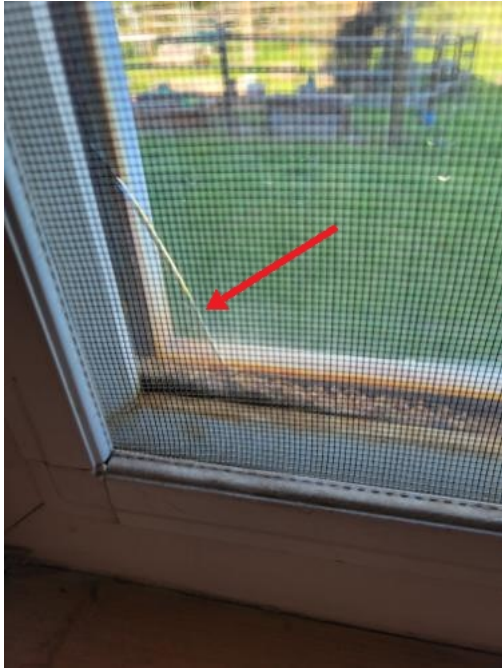
**2.4) Window Conditions** R

Broken glass pane(s) were observed at . Recommend repair as needed. The thermal pane window(s) at appear to have lost its / their thermal seal. Moisture, fogging, and hazing are common signs of this condition. While mostly cosmetic, this condition is generally not repairable. Correction would require replacement of the window(s) or window pane(s).

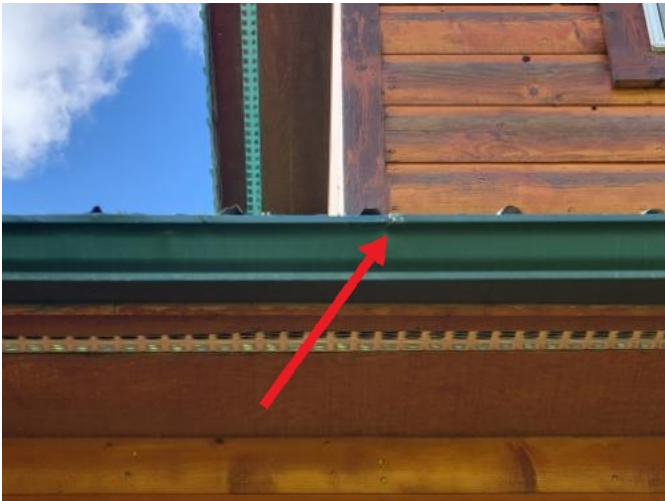
#### 3.3) Gutter & Downspout Conditions

The gutters were damaged and need repair at north west section.

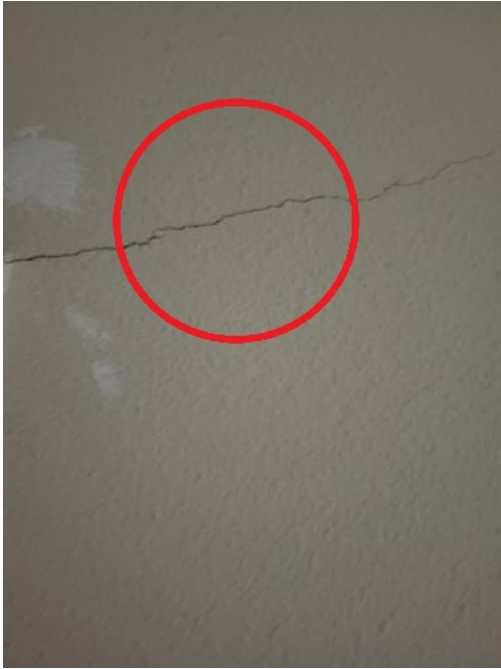
#### 7.1) Wall Conditions

There were common settlement type cracks and nail pops observed to the interior walls. Although these conditions are common in most homes, client is advised to monitor cracks for future movement.

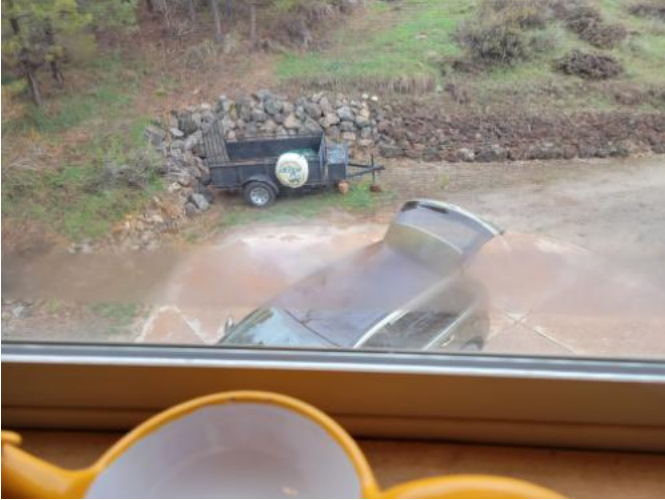
### 7.5) Interior Window Conditions

The thermal pane window(s) at appear to have lost its / their thermal seal. Moisture, fogging, and hazing are common signs of this condition. While mostly cosmetic, this condition is generally not repairable. Correction would require replacement of the window(s) or window pane(s).

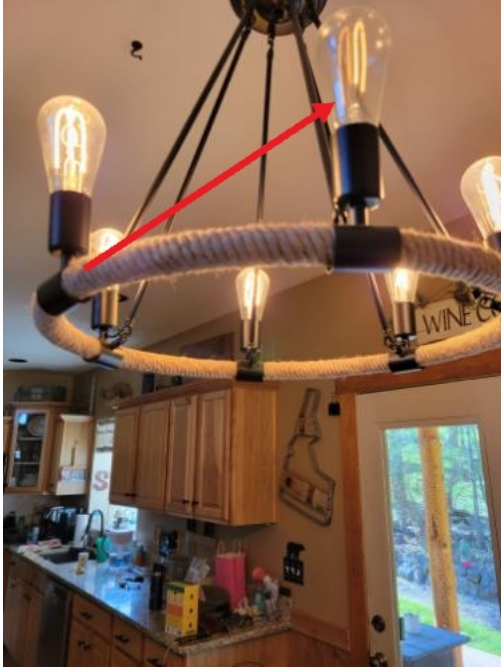
Light(s) were out or inoperative at room. Dismantling and testing of all light fixtures is not performed as part of this inspection. Recommend all lights be operable prior to close.

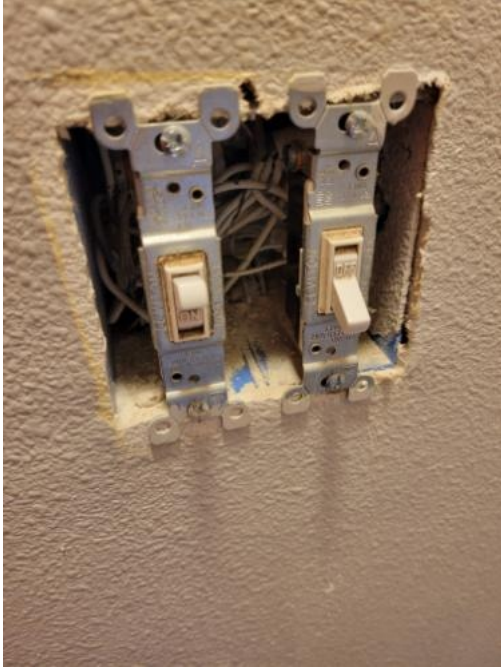
#### 9.7) Electrical Conditions

Missing receptacle or switch covers were observed . Recommend covers be installed for safety.

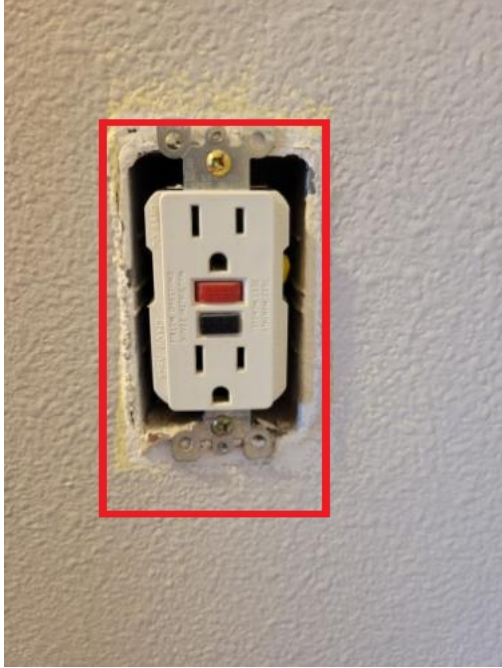
#### 13.7) Electrical Conditions

Cover plate missing.
